## CRYSTAL LAKE FLOODING STUDY

### **PREPARED FOR:**

City of Crystal Lake  
100 W. Municipal Complex  
Crystal Lake, Illinois 60039-0597

**REVISED MARCH 19, 2009**

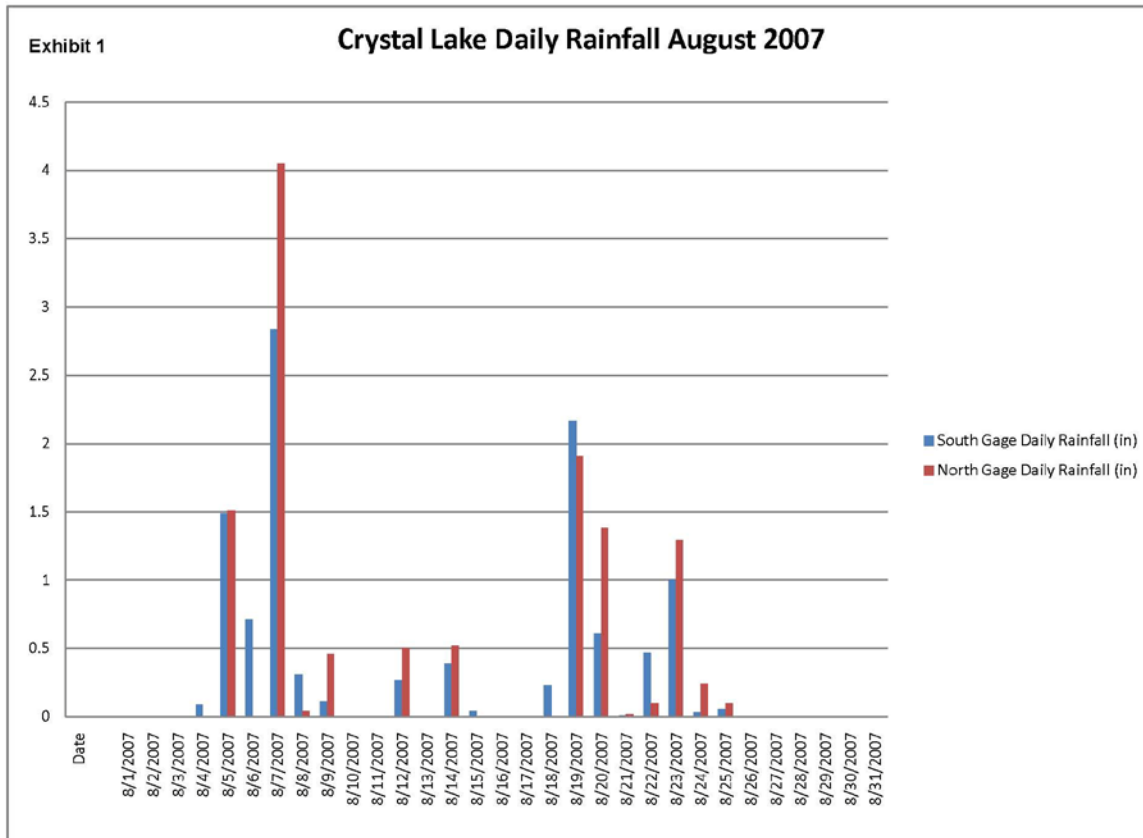
In August of 2007, the area surrounding Crystal Lake received between 11 and 12 inches of rainfall as shown in Exhibit 1. Prior to this rainfall, Crystal Lake had been near or above its spillway elevation of 890.9 for the entire year.

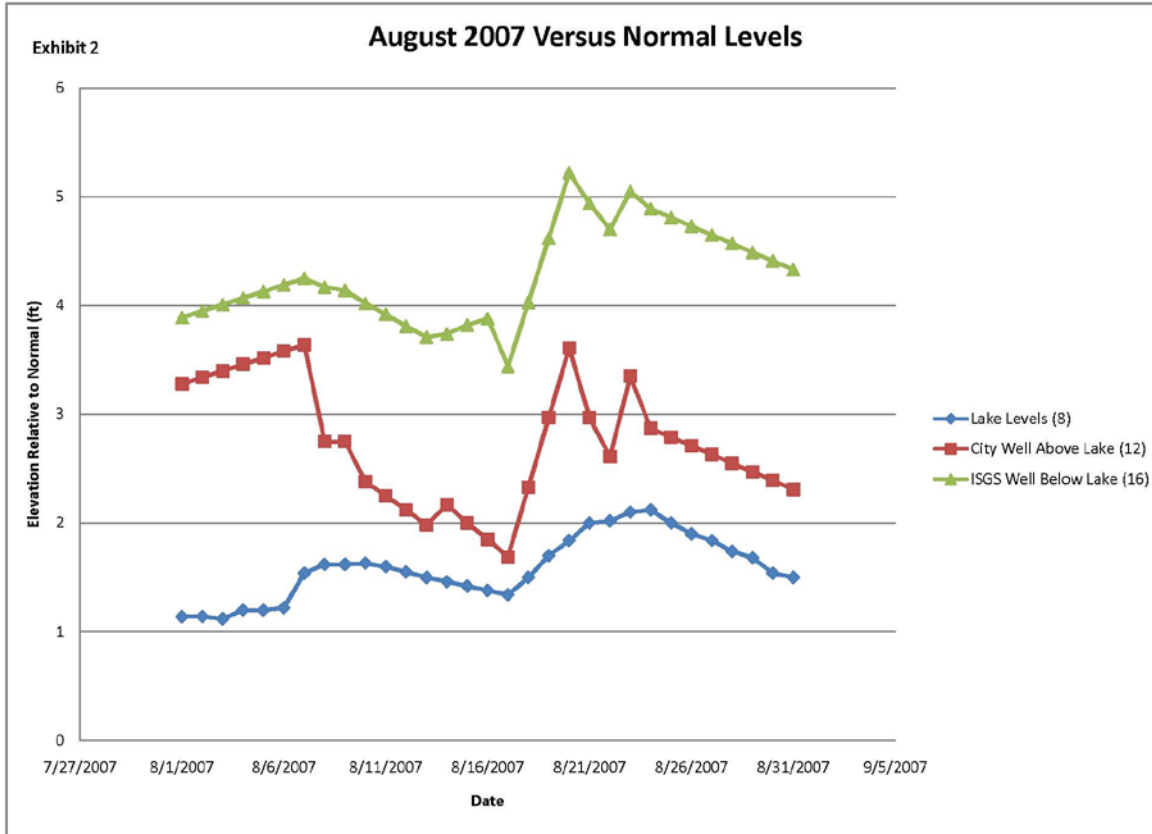
The rainfall produced the highest lake level ever recorded and groundwater levels around the lake reached the ground surface in several locations. Storm sewers were at capacity, overland flow occurred and depressions filled with water that could not drain fast enough. Exhibit 2 shows how lake and groundwater levels exceeded normal circumstances.
