# APPENDIX A

## St. Mary's Analysis and Exhibits

RE: St. Mary's Episcopal Church – Tarpley/Gates House

# ASBESTOS BULK BUILDING INSPECTION

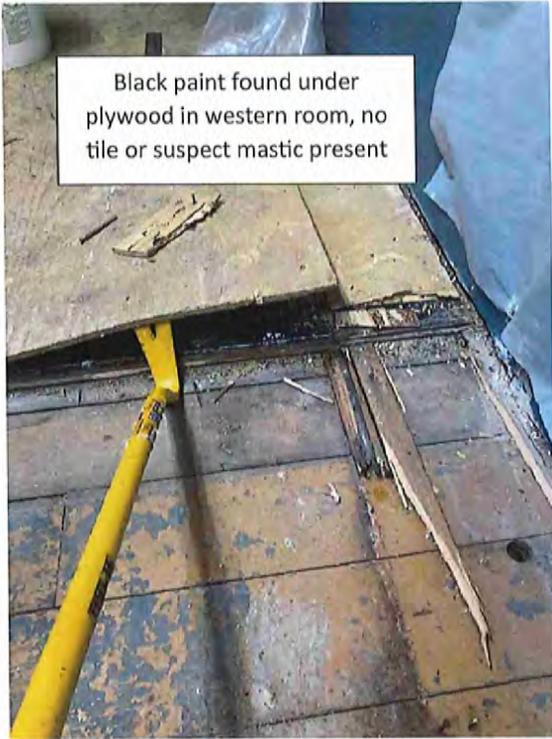
Black paint found under plywood in western room, no tile or suspect mastic present

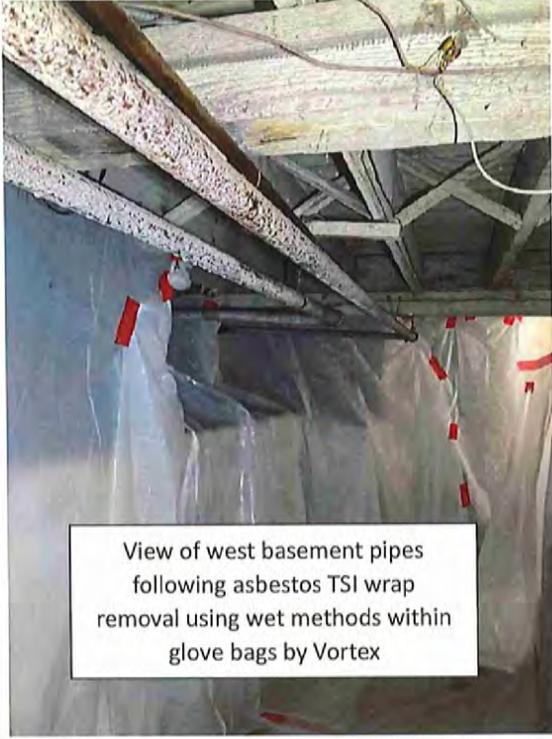
View of west basement pipes following asbestos TSI wrap removal using wet methods within glove bags by Vortex

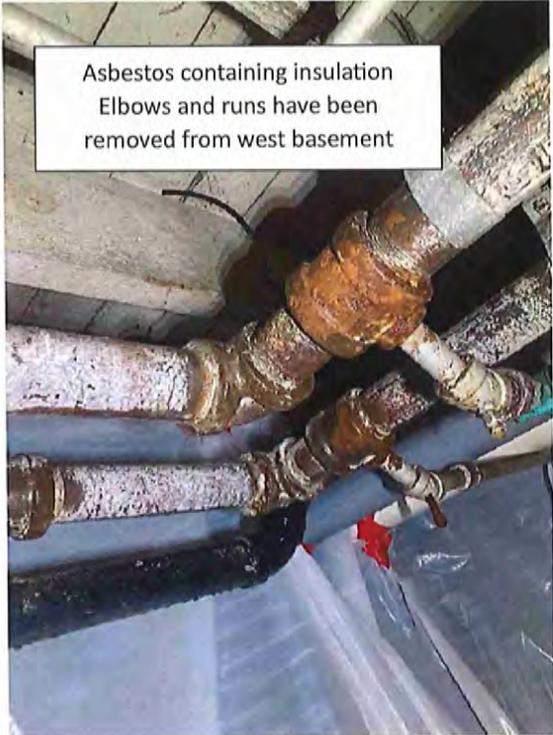
Asbestos containing insulation Elbows and runs have been removed from west basement

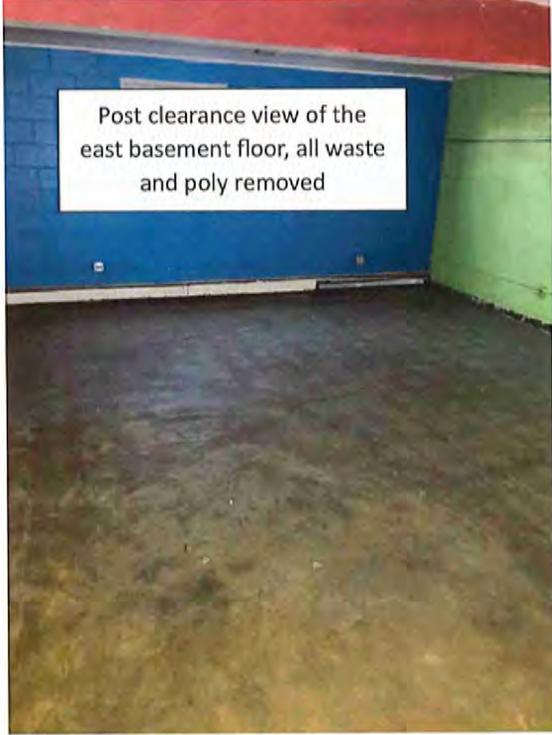
Post clearance view of the east basement floor, all waste and poly removed

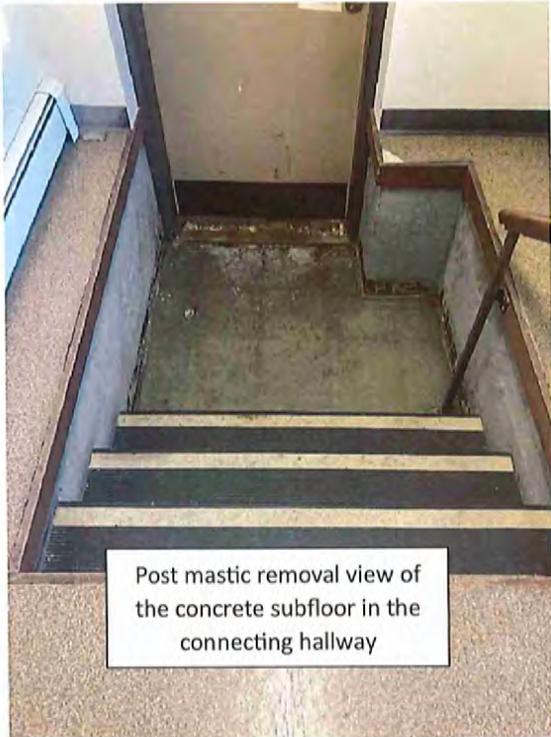
Post mastic removal view of the concrete subfloor in the connecting hallway

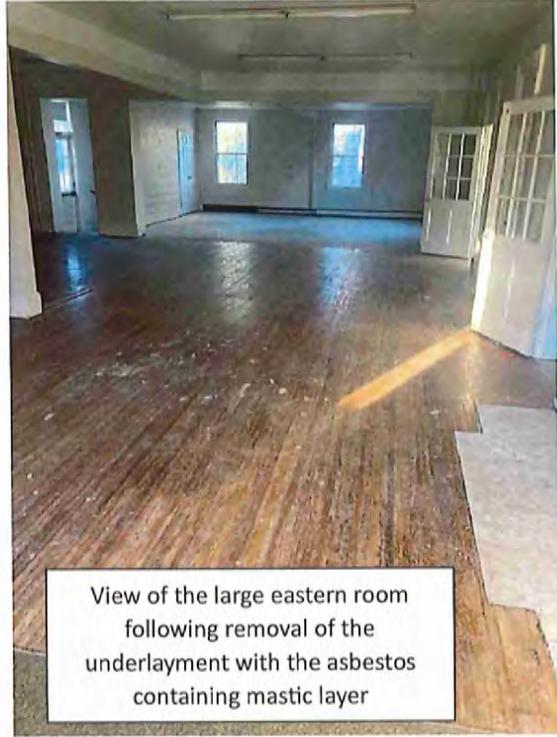
View of the large eastern room following removal of the underlayment with the asbestos containing mastic layer

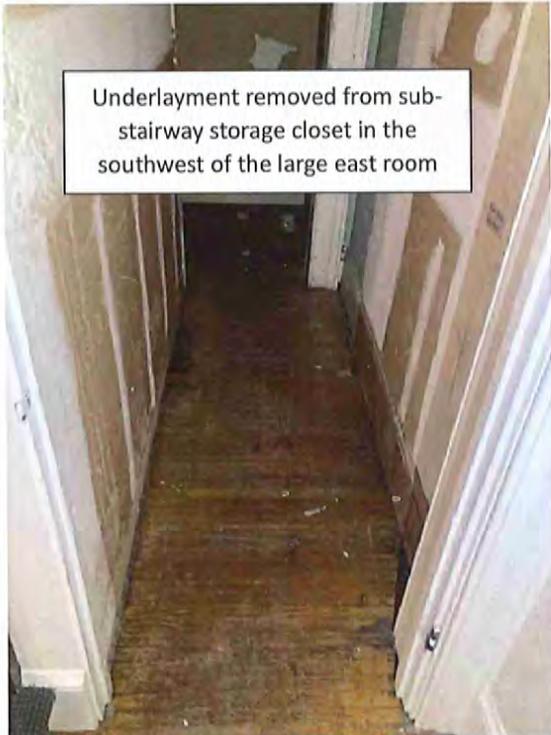
Underlayment removed from sub-stairway storage closet in the southwest of the large east room

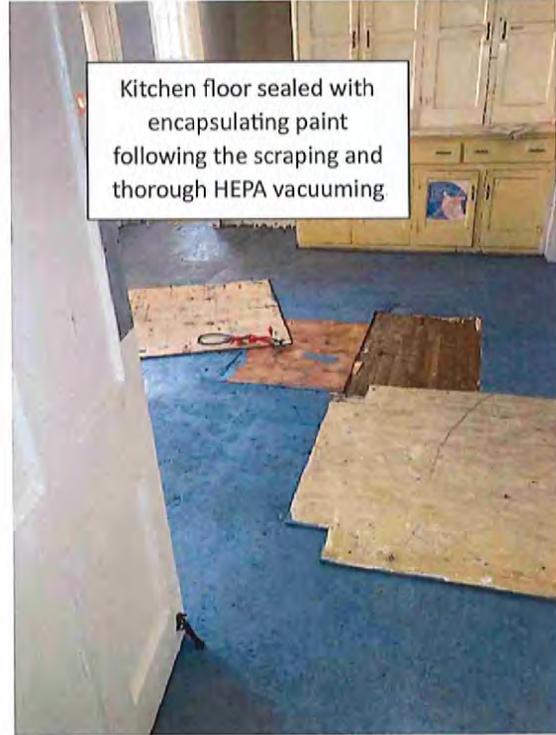
Kitchen floor sealed with encapsulating paint following the scraping and thorough HEPA vacuuming

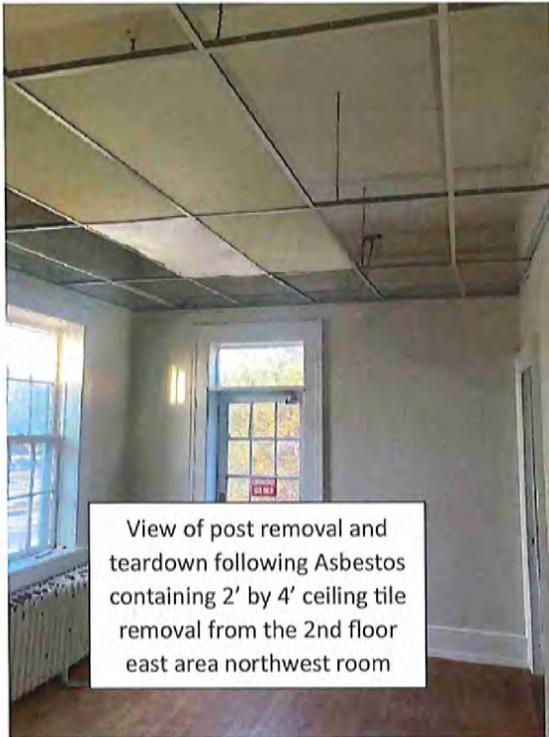
View of post removal and teardown following Asbestos containing 2' by 4' ceiling tile removal from the 2nd floor east area northwest room

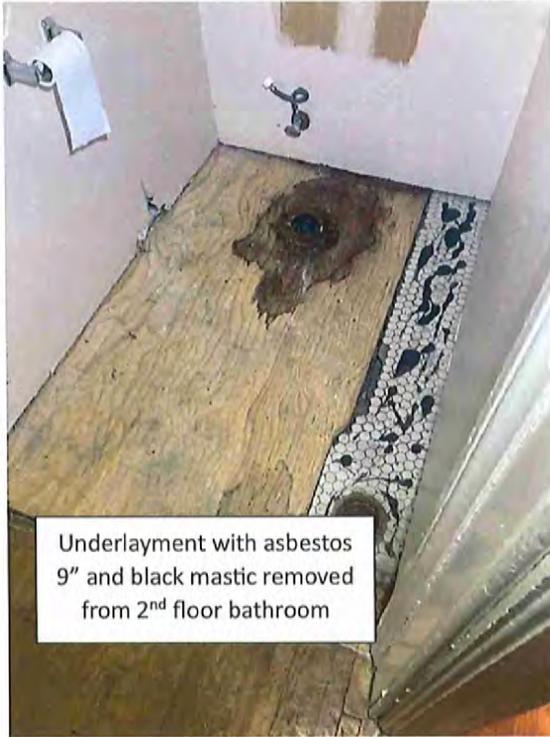
Underlayment with asbestos 9" and black mastic removed from 2nd floor bathroom

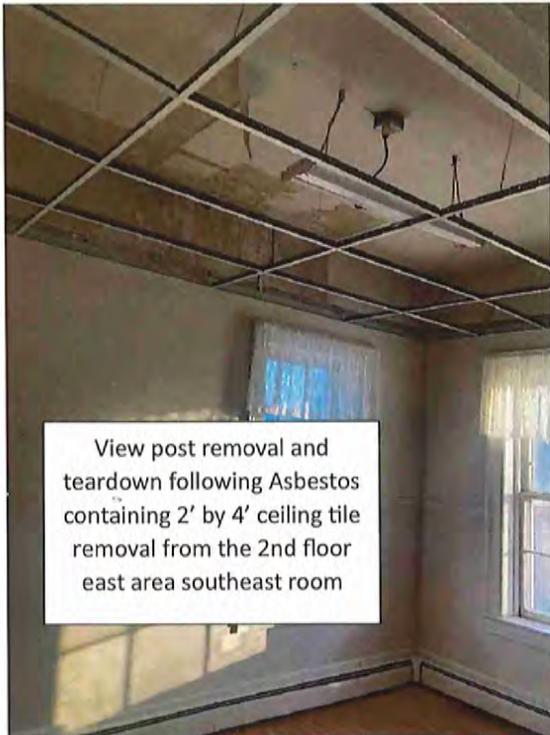
View post removal and teardown following Asbestos containing 2' by 4' ceiling tile removal from the 2nd floor east area southeast room

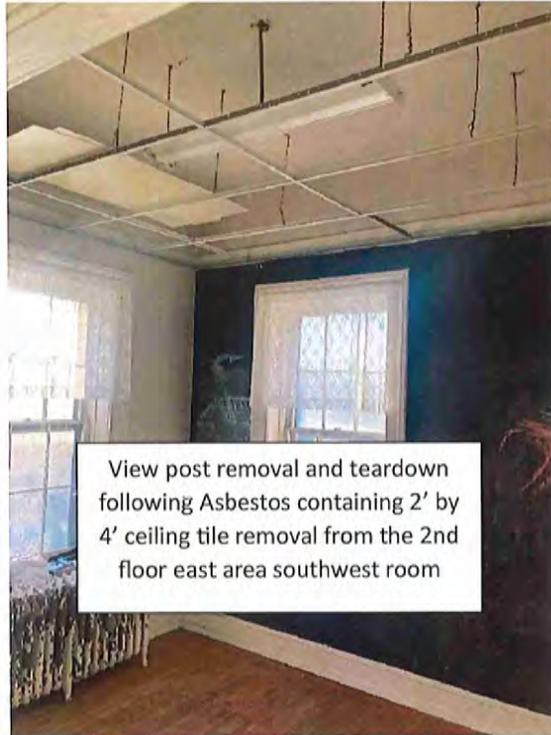
View post removal and teardown following Asbestos containing 2' by 4' ceiling tile removal from the 2nd floor east area southwest room

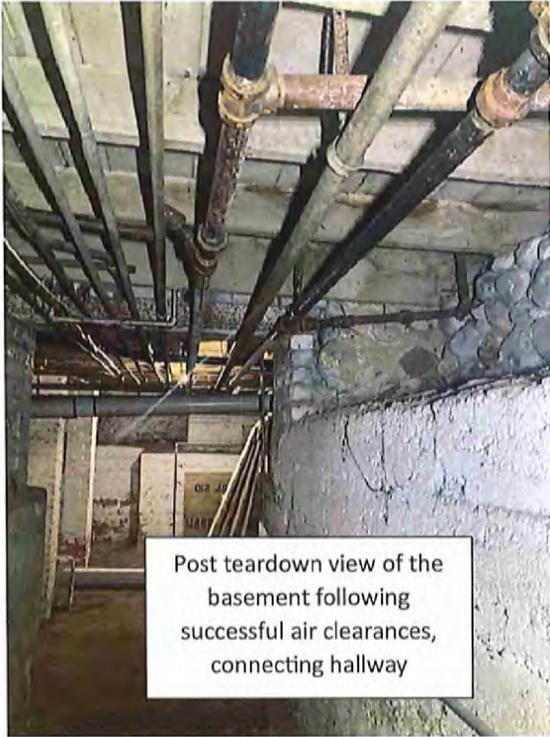
Post teardown view of the basement following successful air clearances, connecting hallway

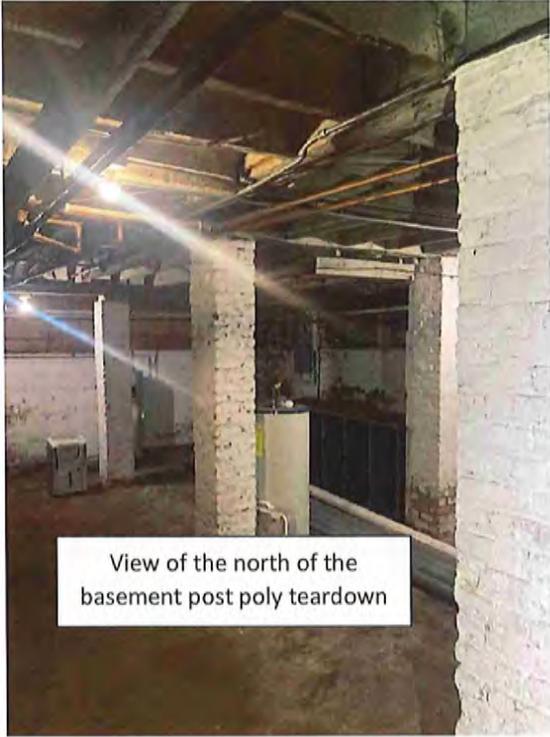
View of the north of the basement post poly teardown

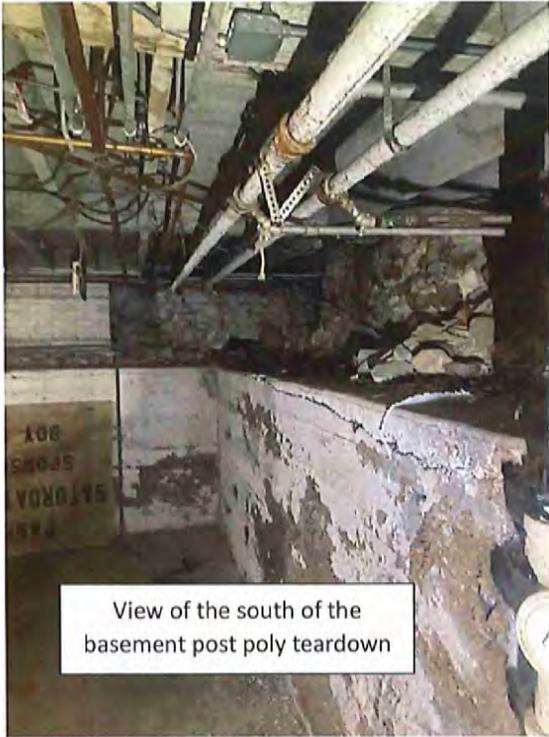
View of the south of the basement post poly teardown
