# Crystal Lake Flooding Analysis

August 2007 Conditions

## Flood Complaint Area 4

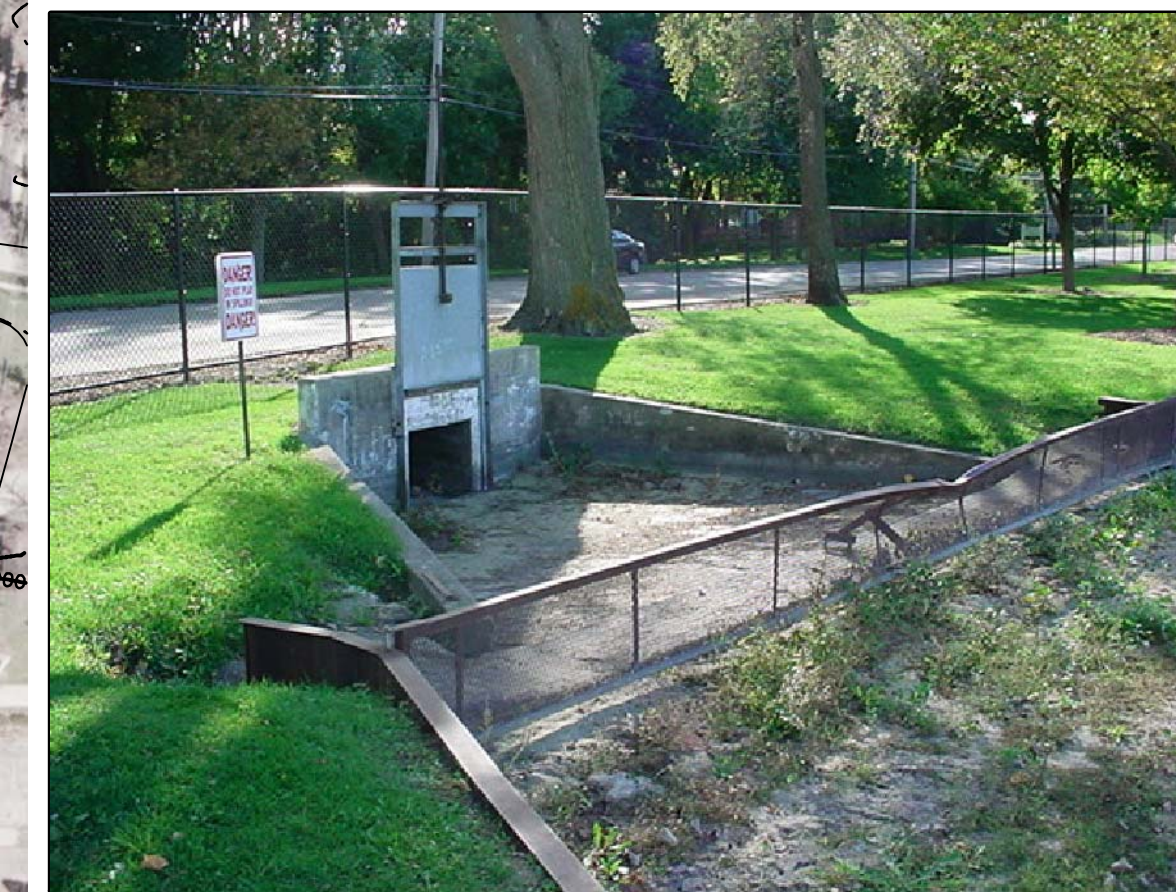
Spillway Photo
